**carspector**Auto gecheckt,
sicher gekauft.

Vehicle Data and Inspection Conditions

Client	Inspector	Date
M. Hoffmann	Carspector / W.	15.03.2025

Manufacturer	Audi	VIN	SAMPLE
Model	A6	Type	Wagon
Transmission	Automatic	First Registration	03/22
Fuel	Diesel	Color	Black
Engine	1.968 cm ³	No. Doors	4/5
Power	120 kW (163 hp)	Next HU	10/26
Mileage	36.326 km	Emission class	Euro 6 - Green badge

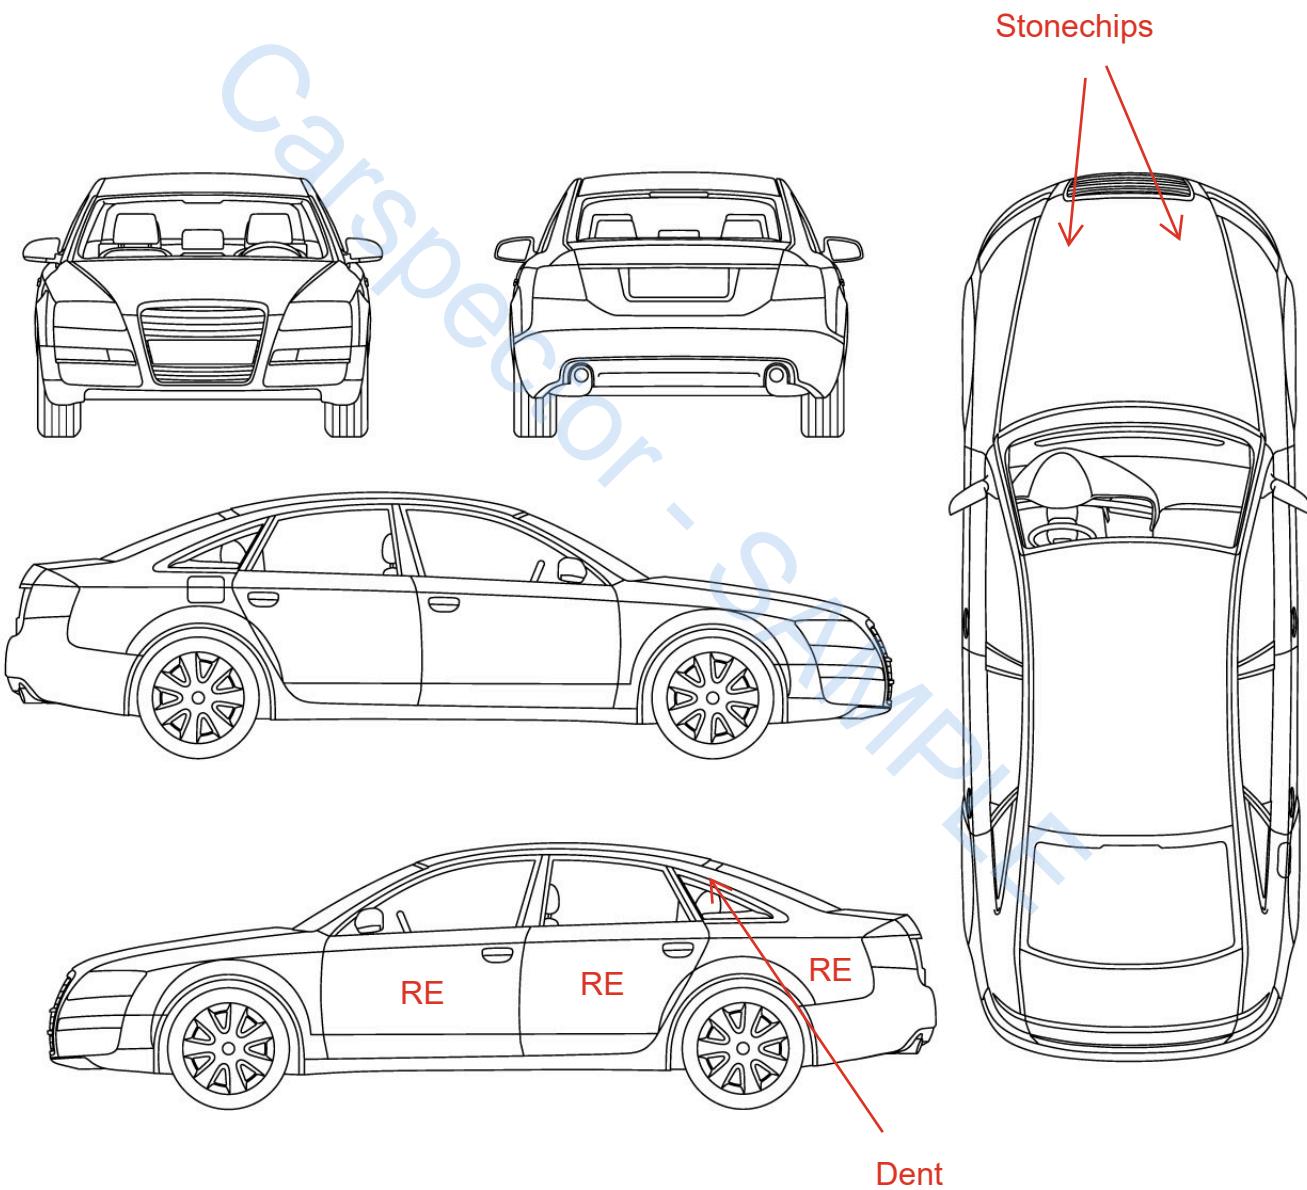
Vehicle overview

Component	Paint layer thickness in μm	Repainted?	Condition
Hood	126	No	● Stone chip
Fender FR	131	No	●
Fender FL	137	No	●
Door FL	● 425	Yes	●
Door BL	● 383	Yes	●
Door FR	123	No	●
Door BR	137	No	●
Sidewall BL	● 415	Yes	● Dent in the upper area
Sidewall BR	128	No	●
Roof	126	No	●
Tailgate	117	No	●

Front bumper	● Scratches on the left side
Rear bumper	● Scratches on the left side
Grill	●
Left sill	●
Right sill	●
Panel Gaps	●

Errors in Instrument Cluster	● No errors
Diagnostic Tool	● No errors
Known Accident Damage	● Left side
Repainted Areas	● Left side (door VL, door HL, side panel HL) Reason: Scraped against a wall in a parking garage
Other Abnormalities	-
